**RCRA Compliance Branch
INSPECTION REPORT**

Inspection Date(s):	07/23/2019 – 07/25/2019		Inspection Announced: No
Facility or Site Name:	Troy Chemical Corporation		
Facility/Site Physical Location:	One Avenue L		
(city, state, zip code)	Newark, NJ 07105		
Mailing address (if different from above):	One Avenue L		
(city, state, zip code)	Newark, NJ 07105		
Facility/Site Contact:	Bill Reilley	Environmental Manager	
	reilleyw@troycorp.com		
	973-508-4628		
RCRA ID Number:	NJD002144517 *		
Facility/Site Personnel Participating in Inspection:			
Alexander Gerardo	Vice President of Government Affairs	gerardoa@troycorp.com / 973-477-0559	
Sam Eskander	General Manager	eskanders@troycorp.com / 973-589-0490	
Donn Hirschmann	Environmental Health and Safety Group Director	hirschmannd@troycorp.com / 973-589-2500	
Jim Manzella	Process Safety Manager	manzellaj@troycorp.com / 973-589-2500	
Bill Reilley	Environmental Manager	reilleyw@troycorp.com / 973-508-4628	
Rob Zedeck	Plant Manager	zedeckr@troycorp.com / 973-589-2500

At the request of EPA Region 2, EPA Headquarters supported by Eastern Research Group, Inc. (ERG) conducted a Resource Conservation and Recovery Act (RCRA) compliance evaluation

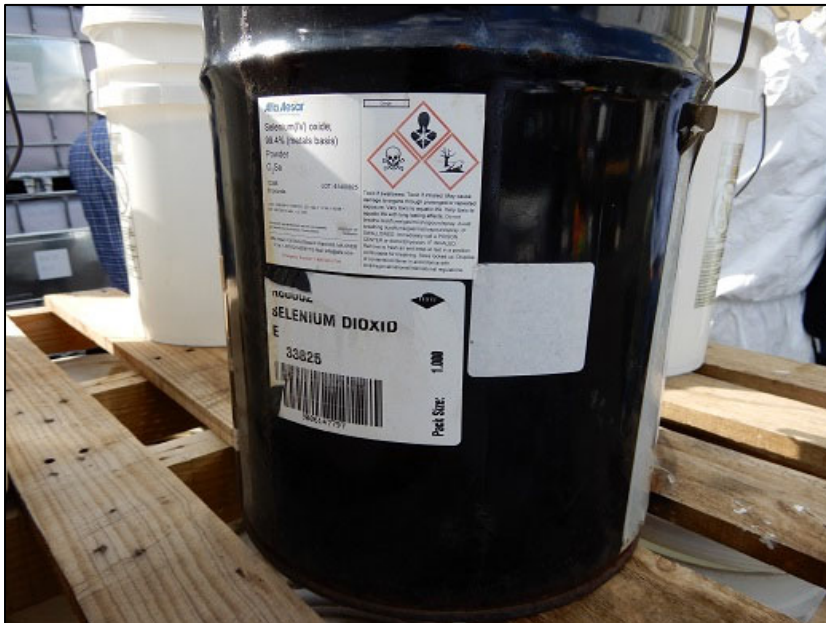
{Photograph 43}

35. {View of one bucket on the pallet from Photograph 43 labeled “Selenium Dioxide.”}

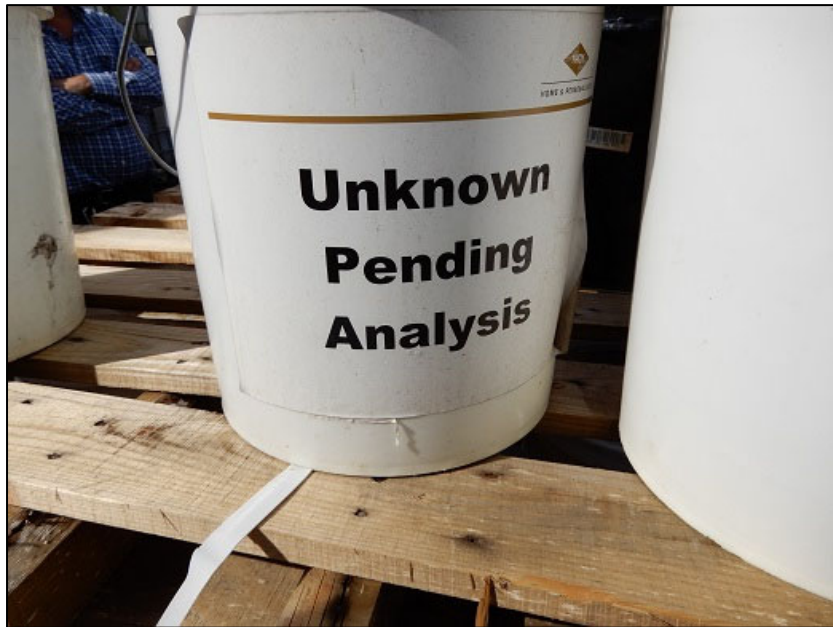
{Photograph 44}

36. {View of another bucket on the pallet from Photograph 43 labeled “Unknown Pending Analysis.”}

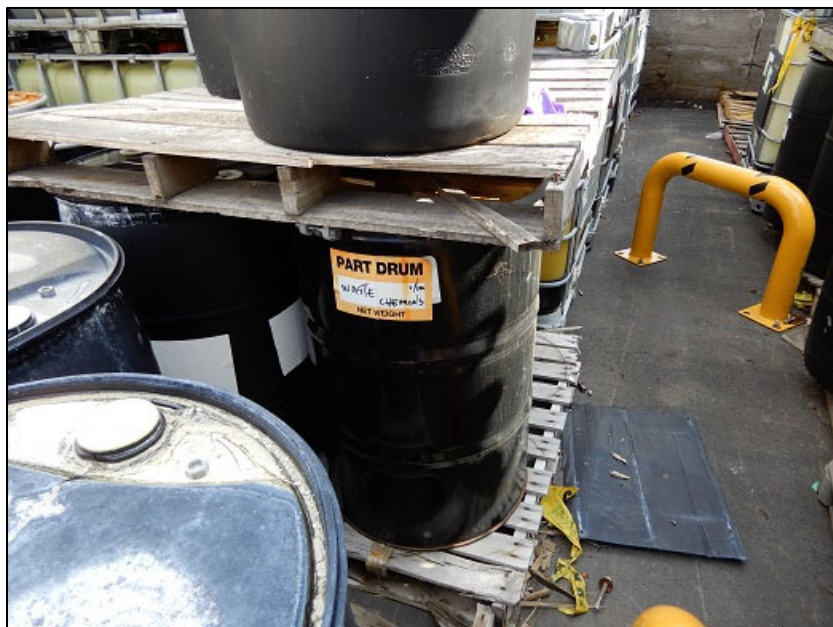
{Photograph 45}

37. {View of a drum near the south side of Building 71 labeled “Waste Chemicals” and dated “1/10.” It was not clear what chemicals were or the hazards associated with the chemicals.}
